## P-97 & P-87 Air System Technical File

RAMP TEST is POSSIBLE

PULL is NOT POSSIBLE

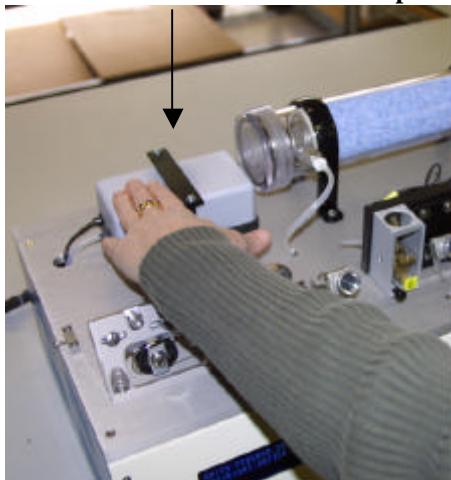
Step 1) Place your hand on the pump (to the back left on the base plate and next to the Drierite canister) to feel if it is vibrating. Often you can also hear the pump running or air blowing if there are not too many other noises in your lab. If the pump is running constantly or sputtering on and off, you have an air leak and the puller can not achieve the default 2 psi of air pressure required to cool the glass when it is being pulled. Proceed to “Step 2.” If the pump is not vibrating/running, please proceed to “Step 4.”

**Check to See if Pump is Running or Sputtering.**

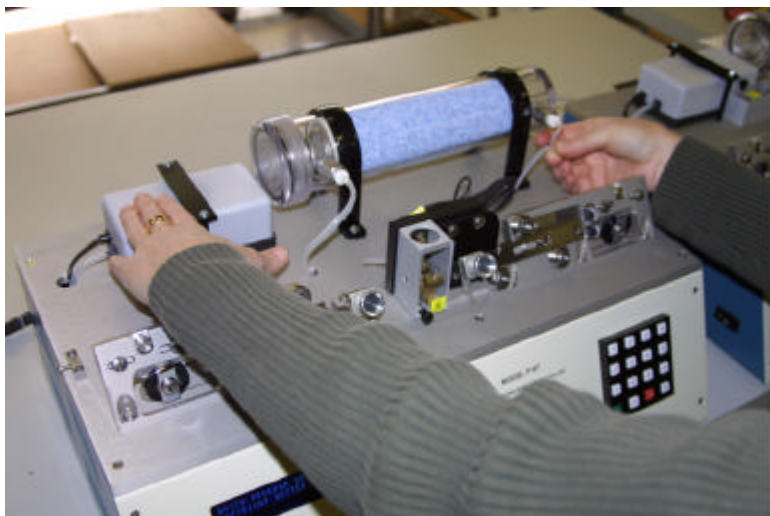
Image A

Step 2) If your pump is running, fold and pinch in half the tubing coming from the right port of the Drierite canister (the clear plastic tube with blue granules in it), and see if this makes the pump stop running (Image A). If the pump stops running, this indicates that your Norgren Reedex valve is stuck open and/or the wiring between the Norgren Reedex valve and the board is faulty causing an air leak.

**Pinching off tubing from Right Port of Drierite Canister**

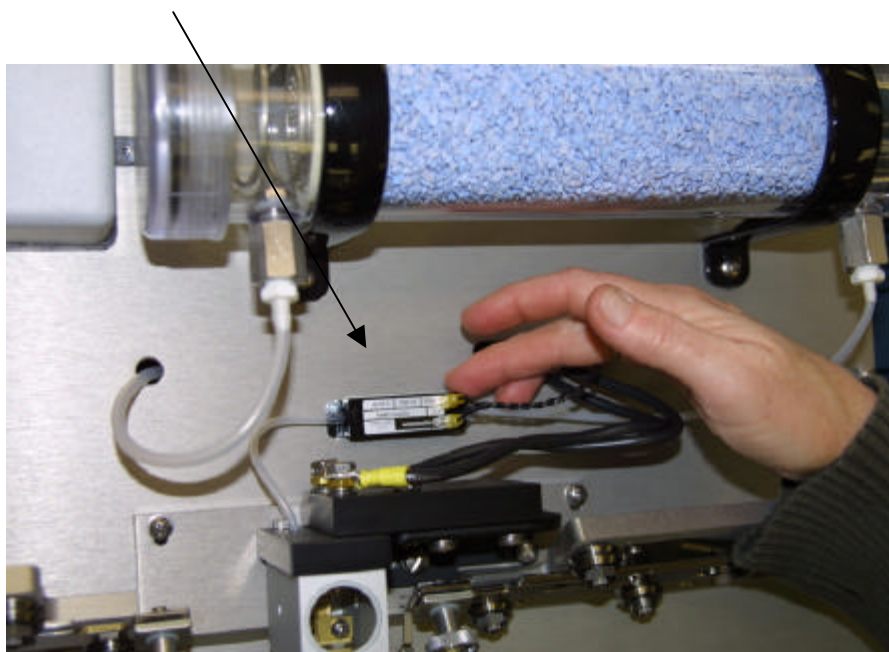
Image B

The Norgren Reedex valve is the small rectangular black plastic on/off valve located behind the filament block assembly and has two small wires with yellow connectors (Image B). Contact Sutter and let us know you need a new Norgren Reedex valve and new wiring which connects the Norgren Reedex valve to the motherboard.

#### **Norgren Reedex Valve and Wiring, Part # V100097**

Step 5) If your pump activated when removing the tubing, then the pump is working, but the air flow is stuck closed and this is most likely due to a faulty Norgren Reedex valve. The Norgren Reedex valve is a small rectangular black plastic on/off valve located behind the filament block assembly and has two small wires with yellow connectors (Image B). To test to see if the Reedex is stuck closed, please proceed through the following steps:

If the filament does heat up after these steps, this indicates that your Norgren Reedex valve (Image B) is stuck closed. Please contact Sutter to order a new air valve (Part # V100097), the wire connectors to the main board, and the repair instructions.

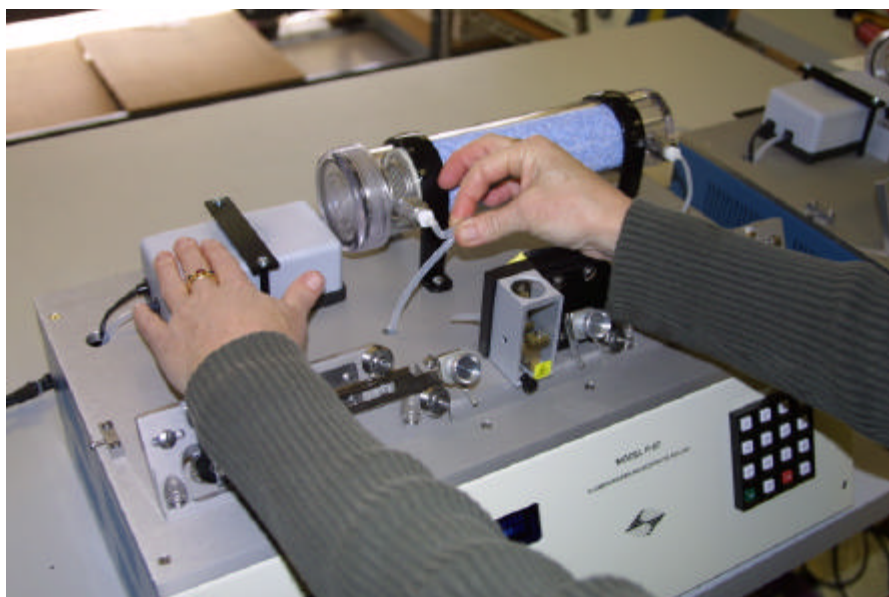
Image C

Step 3) If the pump does not stop, fold and pinch in half the tubing running from the left port of the Drierite canister (Image C) and see if this causes the pump to stop running. If this does cause the pump to stop running, you might have a hole in your tubing or the Drierite cap is loose. It is possible and quite common to develop an air leak after replacing the Drierite Granules since the cap to the Drierite canister can easily get cross threaded or placed on too loose. Please remove the canister, remove the cap, place a little vacuum grease on the black o-ring, and make sure the o-ring is in place and there are no particles or granules on the edge of the canister. Press down evenly on the cap to compress the spring, and tighten the cap. Reconnect the tubing and see if you have fixed the air leak.

#### **Pinching off tubing from Left Port of Drierite Canister**
