## P-97 & P-87 Air System Technical File

RAMP TEST is POSSIBLE

PULL is NOT POSSIBLE

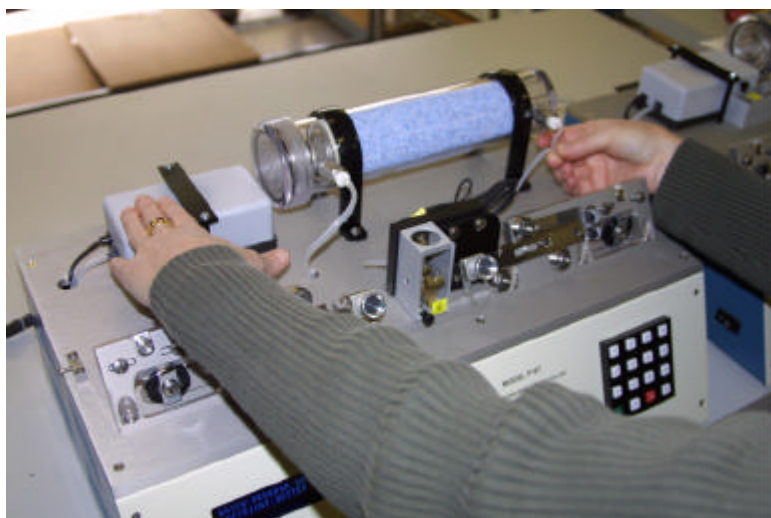
Image A

Step 2) If your pump is running, fold and pinch in half the tubing coming from the right port of the Drierite canister (the clear plastic tube with blue granules in it), and see if this makes the pump stop running (Image A). If the pump stops running, this indicates that your Norgren Reedex valve is stuck open and/or the wiring between the Norgren Reedex valve and the board is faulty causing an air leak.

**Pinching off tubing from Right Port of Drierite Canister**

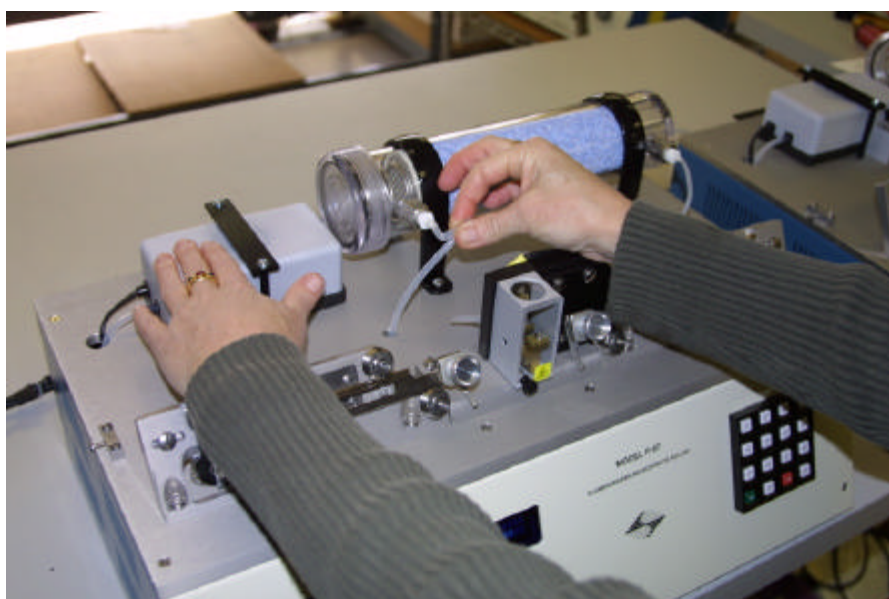
Image C

Step 3) If the pump does not stop, fold and pinch in half the tubing running from the left port of the Drierite canister (Image C) and see if this causes the pump to stop running. If this does cause the pump to stop running, you might have a hole in your tubing or the Drierite cap is loose. It is possible and quite common to develop an air leak after replacing the Drierite Granules since the cap to the Drierite canister can easily get cross threaded or placed on too loose. Please remove the canister, remove the cap, place a little vacuum grease on the black o-ring, and make sure the o-ring is in place and there are no particles or granules on the edge of the canister. Press down evenly on the cap to compress the spring, and tighten the cap. Reconnect the tubing and see if you have fixed the air leak.

#### **Pinching off tubing from Left Port of Drierite Canister**
